**COMPREHENSIVE PHASE I SAMPLING
SUMMARY REPORT
FOR
DETROIT LEAD ASSESSMENT PROJECT
DETROIT, WAYNE COUNTY, MICHIGAN**

WESTON SOLUTIONS OF MICHIGAN, INC.

February 2004

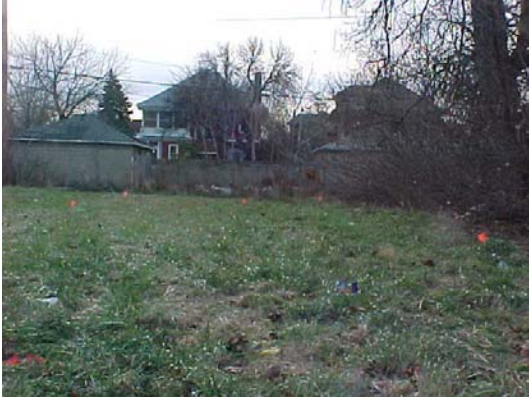
532 Harmon – Vacant property located on the southeast side of Harmon St and directly southwest of a burned down abandoned house.

Looking southeast along the vacant property at 5 discrete sample A locations.

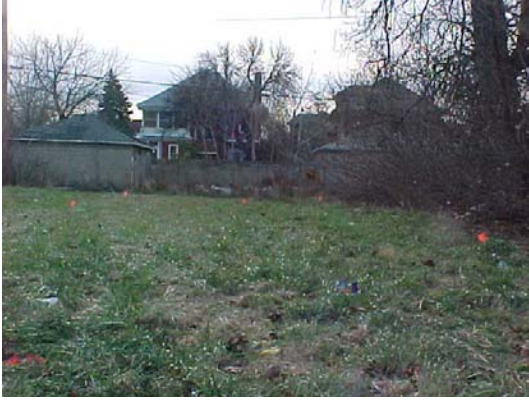
532 Harmon – Vacant property located on the southeast side of Harmon St and directly southwest of a burned down abandoned house.

Looking southeast along the vacant property at 5 discrete sample A locations.

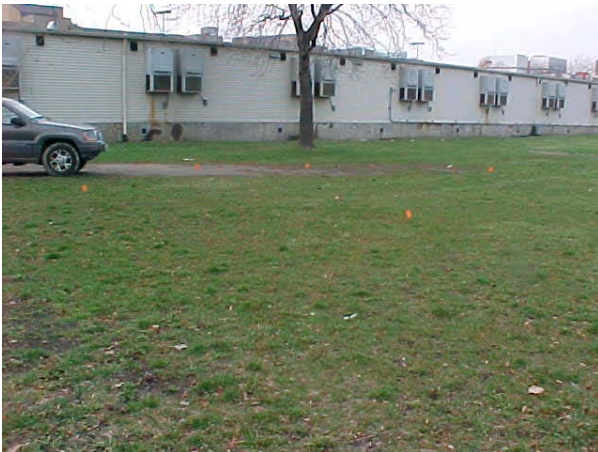
Looking west along the property at 5 discrete sample F locations.

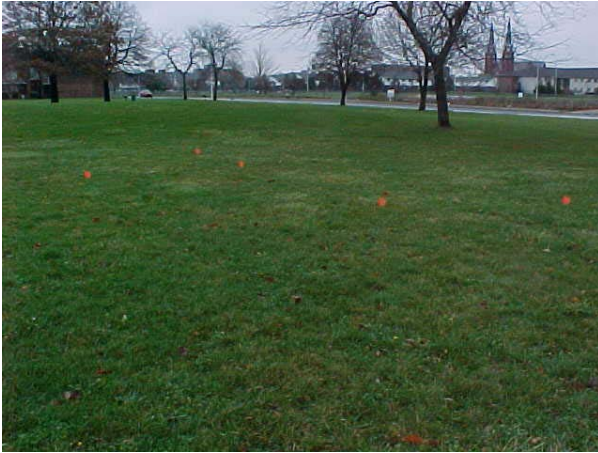
701 Mack – Property located on the southwest side of Chrysler Dr. This is the area furthest to the northwest end of the Edward Tolan Playfield. The property was broken into the east, between east and west, and west ends for the sampling areas.

Looking north along the property at 5 discrete sample G locations.
